Real-Time Monitoring Advances Landslide Risk Management

By Angus W. Stocking

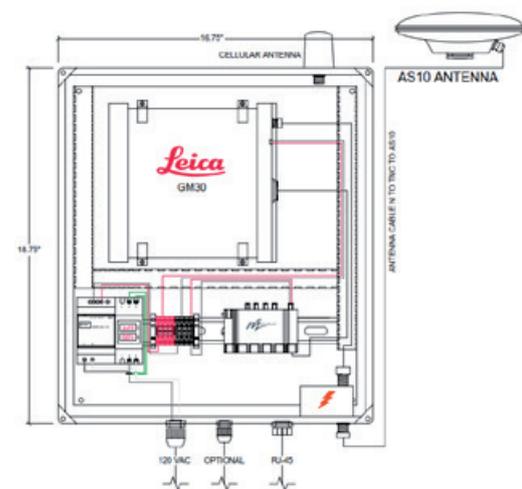
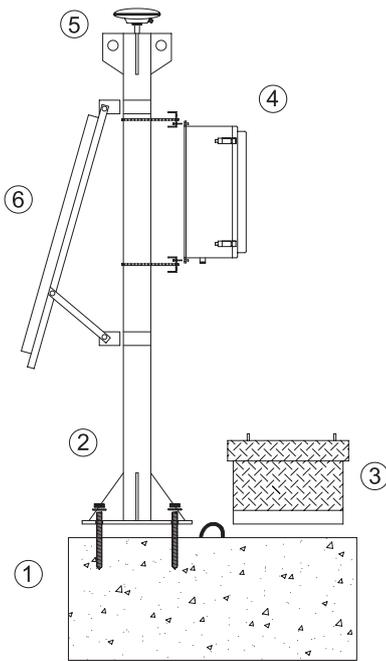
Design was crucial to the success of the system. The monitoring solution had to track the landslide in three dimensions at the millimeter level around the clock and measure the precise displacements in real-time. The innovative monument design is likely to be influential in landslide monitoring projects for years to come.

GM30 receivers required a robust DC power system based around solar energy. This consisted of an appropriately sized solar panel and a battery array capable of providing power in any weather. To keep the entire system "bottom heavy" and resistant to wind toppling, Leica Geosystems designed a minimally expanding concrete cylinder base that weighed well over 1,700 pounds, giving the entire installed assembly a weight of over a ton.

"The alternative to a system like this would have required getting a drill rig on site to place a deep foundation," says Rutledge. "But that would have quadrupled costs and likely wouldn't have been a better solution. We match our monumentation with the expected displacement signal, an often-overlooked aspect of measurement science. The design and special concrete mix meant that we could fabricate everything up near the site in just a couple of days. We felt that we had found a good way to mount the GM30s that worked with the particular conditions in Old Fort, and their performance since then has proved us correct. We now track the slide in the low millimeter range."

that is known to be dangerously unstable? In a word, helicopters—the initial six concrete bases with mounting brackets, the battery packs and solar arrays, and of course the GM30s were staged at a restricted area near the landslide and then, over the course of one day, lifted and lowered to sites spread out strategically over the landslide (aside from one receiver installed away from the landslide and used as a base station). "In most cases, the sensors were placed on spots that surveyors could walk to safely and then do the necessary assembly on the bases and components as they were lowered in by helicopter," MacIsaac explains. "But we did place a few in spots where there was no reasonable access by foot, and in those cases we went ahead and lowered in the surveyor too—an unusually exciting day of fieldwork for our team!"
